# Manhole Inspection Summary

Manhole # S15YY\_024MH

**Location** Address: **3500 PARK HEIGHTS AVE**

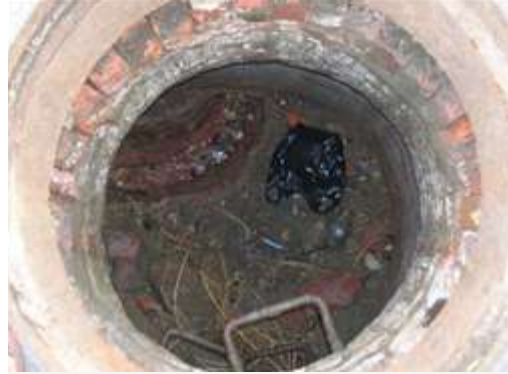
Top View

☐ Parged ☒ **Debris** (not Condition related)

Bench debris.

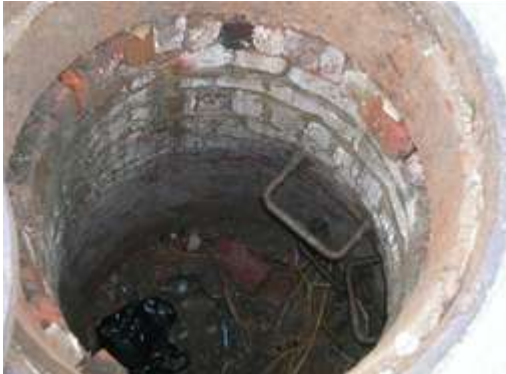
Defect

☒ **Leaks**

Condition: ☐ Sound ☐ Cracked ☐ Root Intrusion ☒ **Loose Brick** ☒ **Deteriorated**

Infiltration: ☐ None ☒ **Joint** ☐ Cracks ☒ **Mortar** ☐ Roots ☐ Wall

Infiltration: ☐ None ☐ Joint ☐ Cracks ☒ **Mortar** ☐ Roots ☒ **Wall**

Frame leaks. Frame offset. Adjustment deterioration, loose brick and infiltration. Barrel infiltration - other side.

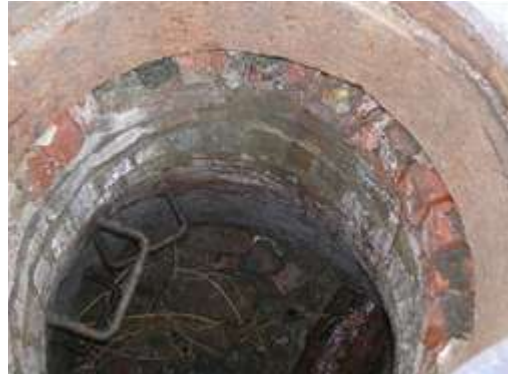
Defect

Condition: ☐ Sound ☐ Cracked ☐ Root Intrusion ☐ Loose Brick ☒ **Deteriorated**

Frame leaks. Frame offset. Adjustment deterioration, loose brick and infiltration. Barrel infiltration.

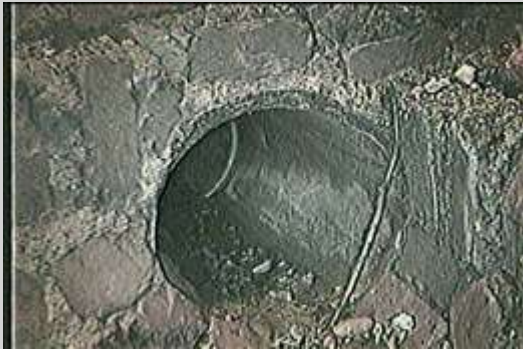
### 8 in. Circular Gravity Sewer Pipe Out @ 12 O'Clock

Deposits: ☐ None ☒ **Mud** ☐ Sludge ☒ **Debris** ☐ Grease

Silt Depth: **0.5** (in.) Deposits Extent: **Light**

Infiltration: **Evidence** Pipe Seal Cond: **Cracked**

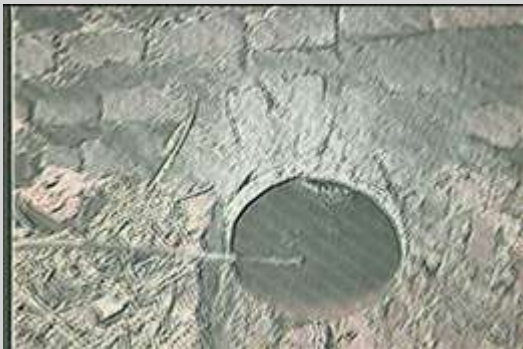
### 8 in. Circular Gravity Sewer Pipe In @ 9 O'Clock

Barrel deterioration and infiltration.

Infiltration: **None** Pipe Seal Cond: **Cracked**
